Fujii, Y, Fodde, E, Watanabe, K & Murakami, K 2009, 'Digital photogrammetry for the documentation of structural damage in earthen archaeological sites: the case of Ajina Tepa, Tajikistan', *Engineering Geology*, vol. 105, no. 1-2, pp. 124-133. <https://doi.org/10.1016/j.enggeo.2008.11.012>

**DIGITAL PHOTOGRAMMETRY FOR THE DOCUMENTATION OF STRUCTURAL DAMAGE IN  
EARTHEN ARCHAEOLOGICAL SITES: THE CASE OF AJINA TEPA, TAJIKISTAN**

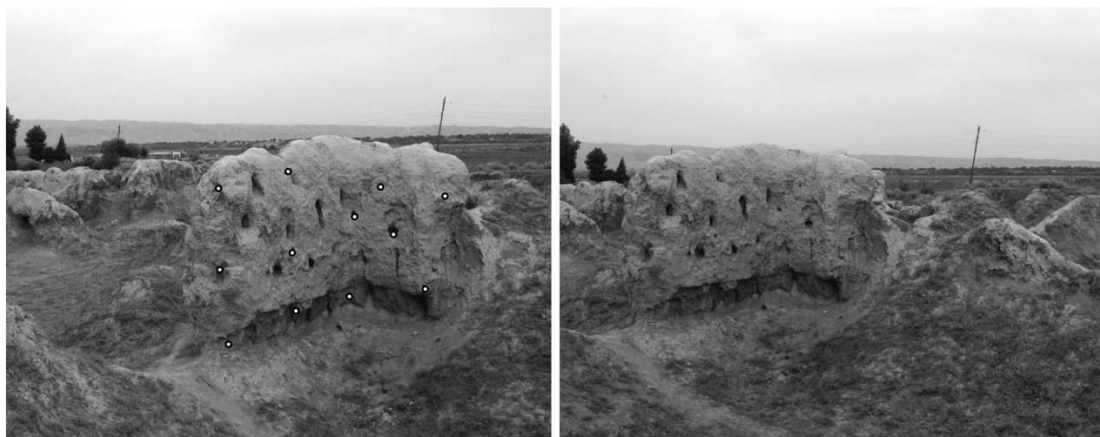
Fig. 2. A pair of stereo-photographs of a damaged wall (Wall A in Fig. 8). White circles on the left photograph show control points.

Using a pair of overlapping digital images (Fig. 2), the three-dimensional (3-D) morphology of a wall can be reconstructed. The information of camera positions and directions, in which the pair of stereo-photographs were taken, are needed to get the three-dimensional co-ordinates. However, it is very difficult to get the accurate positions and directions at the same time when taking the photographs. Coordinates of control points which must be included into photogrammetric evaluation were determined by the use of a geodetic Total Station (TS). The camera positions and directions can be inversely calculated from the control points by means of least-square adjustments (Schenk, 1999, Linder, 2003). A 3-D digital photogrammetric software was employed to calculate the camera positions, and to get 3-D information on the surface topography. After the calculation of camera positions and directions, the software can give matching of the same positions on a pair of digital images due to the difference of color and contrast, and generates 3-D coordinates of the points. Those points are connected with lines, and the surface morphology of the wall is constructed as Triangle Irregular Network (TIN; Fig. 3). It is called Digital Terrain Model (DTM; Fig. 4a). The great advantage of digital photogrammetry is to connect the photo images to a DTM. The result is a texture mapping model, which can be viewed from arbitrary directions (Fig. 4b).

In the site of Ajina Tapa, two benchmarks were settled as reference system on both margins of the boundary between stupa and monastery area (Figure 6). Relative positions of those two benchmarks were measured by TS in the accuracy of less than 15 mm. Coordinates of control points, which were included into stereo-photographs, were determined by TS. At the same time of measuring the control points, the benchmarks were also measured by TS. Therefore, the 3-D coordinate of the position of TS could be calculated by triangulation. Two distances from the benchmarks, one horizontal angle between the benchmarks, and two vertical angles to the benchmarks are measured by TS. Therefore, the position of TS can be calculated by means of LSM. The residual from the calculation of LSA by means of TS, which is called as  $R_{ts}$  for convenience, was 92 mm for the southwestern side of Wall-A (Figure 2).

distance from the cameras to the object. B: the distance between two cameras. C: focal length of the camera (lens). In the case of the southwestern side of Wall-A (Figure 2), H is about 14 m, B is about 4.4 m, C is about 18 mm, and  $\delta_{\text{CCD}}$  is 0.0079 mm. So  $\sigma_{xy}$  is about 6.2 mm, and  $\sigma_z$  is 20 mm. The residual from the calculation of LSA for camera positions and directions, which is called as  $R_{\text{ph}}$ , was 98 mm, and it is much larger than  $\sigma_z$ . The  $R_{\text{ph}}$  is almost as same as the  $R_{\text{ts}}$ .

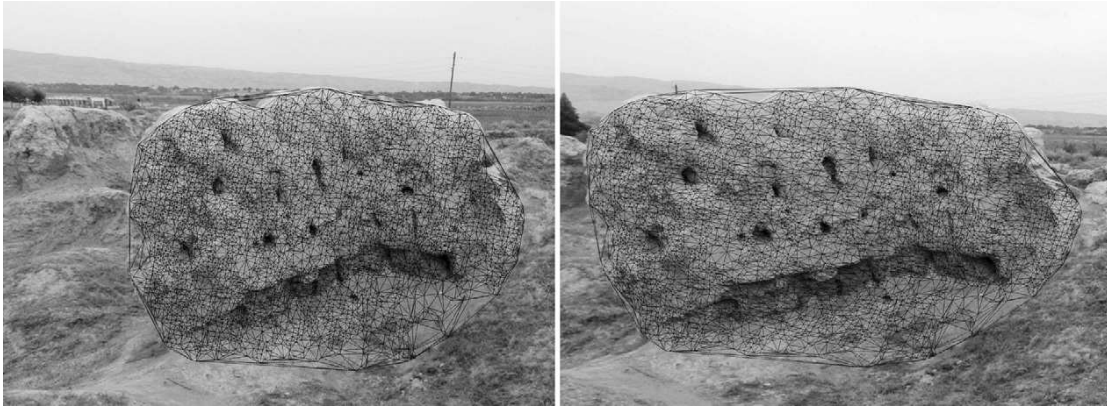
Fig. 3. Triangle Irregular Network (TIN) on a stereo-pair of photographs ( Fig. 2).

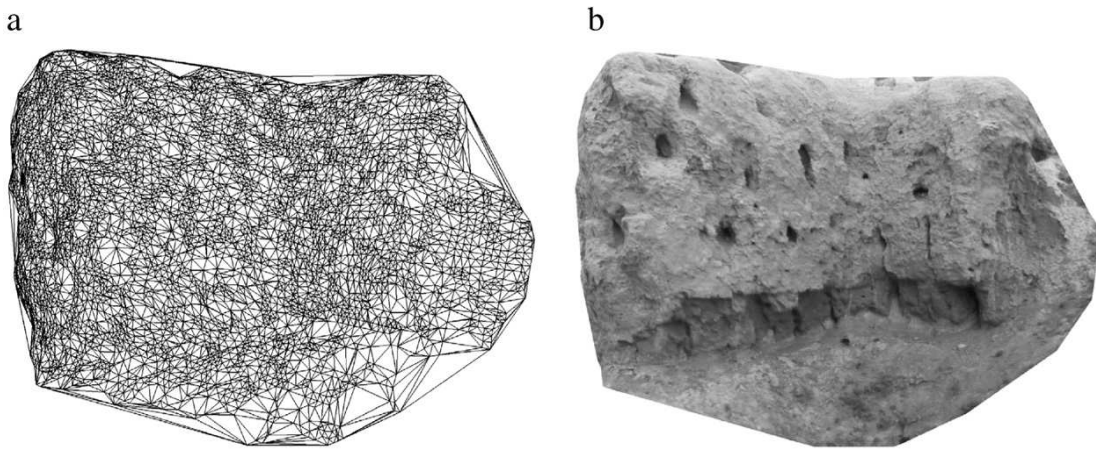
Fig. 4. Digital Terrain Model (DTM) of the damaged wall ( Figs. 2 and 3). a: DTM constructed by means of TIN. b: Texture mapping model. Photo images are put on the DTM.

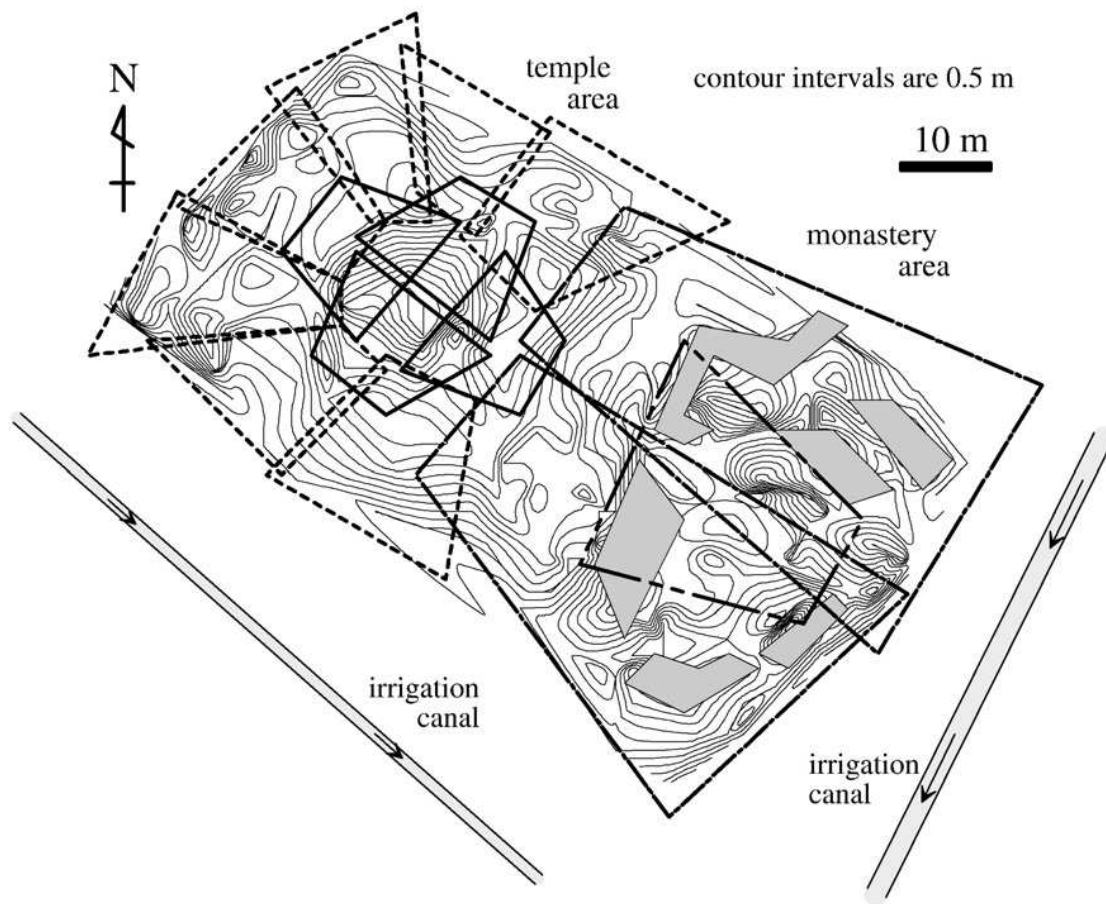
Fig. 5. Parts for taking pairs of photographs for high resolution mapping on low resolution map of the site. Solid and broken polygons (trapezoid) show the positions of 13 pairs of stereo-photographs. Each pair of photographs was taken from the shortest side of each trapezoid. Two pairs of stereo-photographs in the monastery area were taken from the top of the stupa, and some grey areas were hidden by walls.

Fig. 5 shows a low resolution map of the site. This is made from three-dimensional records which have been gained from a mobile Global Positioning System. In the temple area, northwestern part of the site, eleven DTMs were constructed from eleven pairs of

stereo-photographs taken on the ground. The highest position of the site is at the top of the stupa, which is positioned in the center of the temple area. Seven DTMs around the stupa (broken lines in Fig. 5) are made from seven pairs of stereo-photographs which have been taken from the top of the stupa. Other four DTMs (solid lines in Fig. 5) including the stupa are made from photographs, taken from the positions around the stupa. Eleven DTMs cover total part of the temple area. In the monastery area, the southeastern part of the site, three DTMs were constructed. Two pairs of stereo-photographs were taken from the top of the stupa, and another pair of photographs from the southeast rim of the site. The top of the stupa was far from the monastery area. In addition, some areas were hidden by walls when the photographs were taken from the stupa. For example, grey areas in Fig. 5 could not be photographed from the top of the stupa. To obtain a total mapping, direct measurements of the hidden areas were carried out with TS. Figure 6 is the final result of the mapping of the whole site. The maximum height difference of the site is about 7 metres between the top of the stupa and the floor of the monastery area.

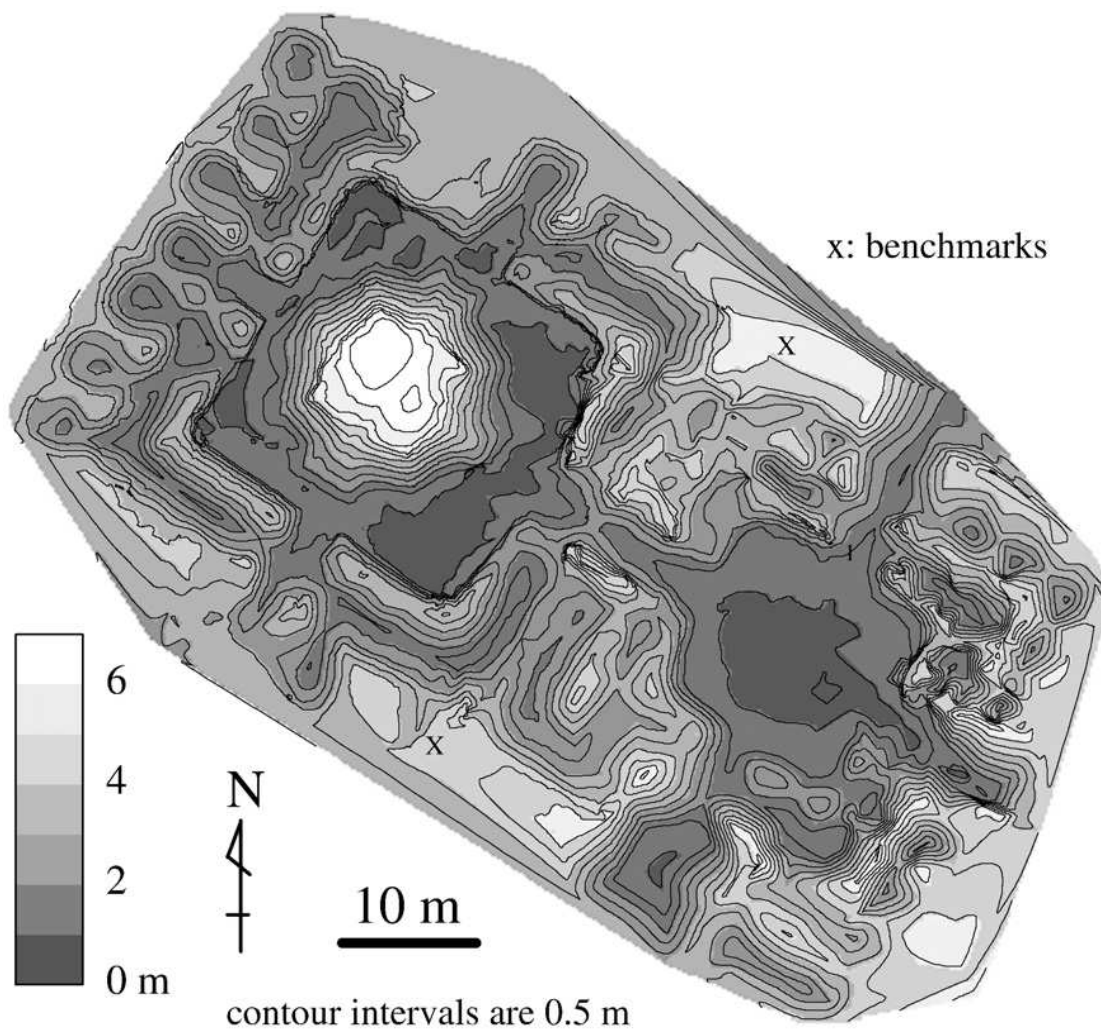
Fig. 6. High resolution map of Ajina Tepa. Topographic coordinates were gained from each pair of photographs

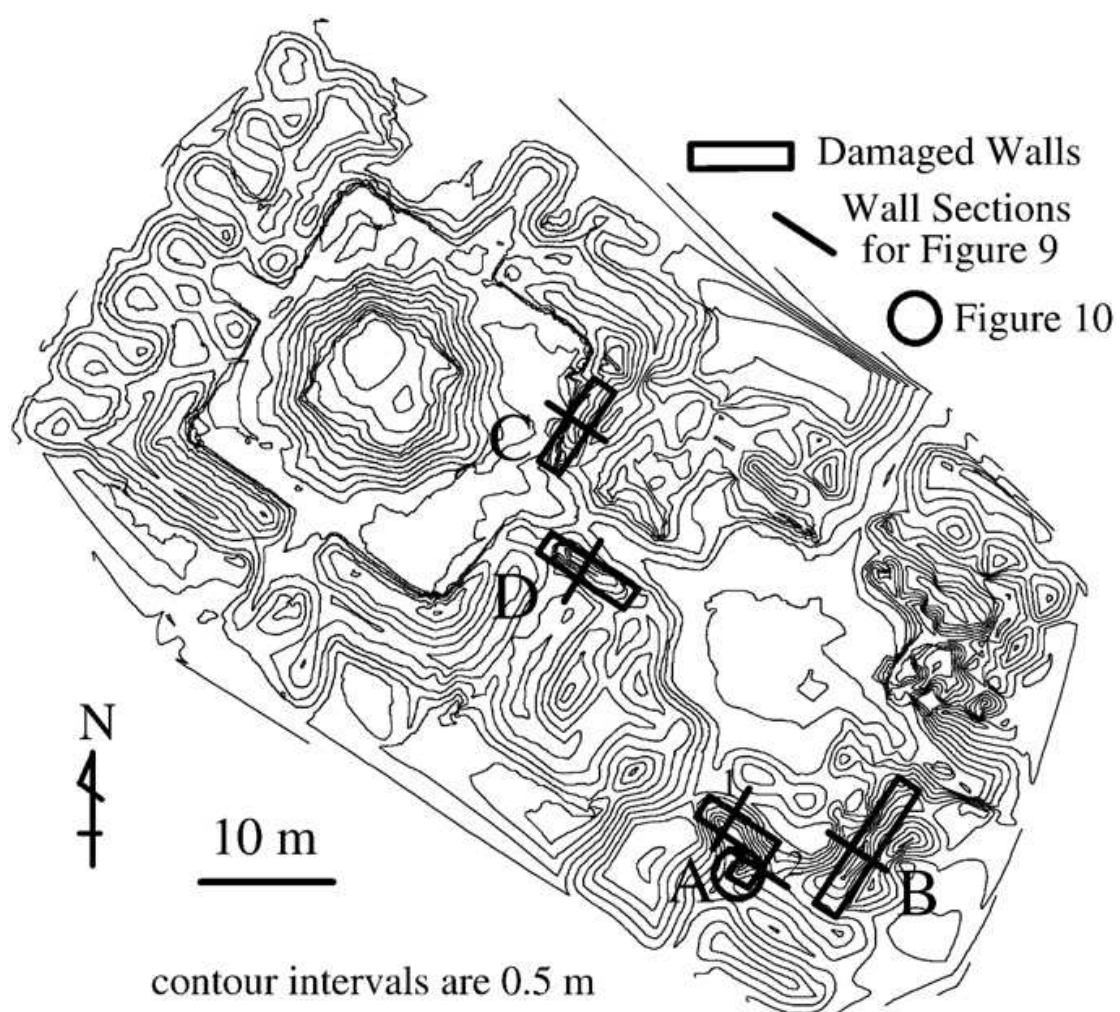
Fig. 7. Location of the damaged walls

Four damaged walls (refer to the frames in Fig. 7) were mapped in 3D with digital photogrammetry. Two pairs of photographs of each wall were taken to make DTMs of both the sides, except for the Wall-A. As to the Wall-A (Fig. 7), which is in reversed L-shape in ground plan, pairs of photographs of the northeast and southeast sides were taken from the northeast and southeast directions respectively, and another pair of photographs of the L-shaped wall

Some measured sections of damaged walls are shown in Fig. 9a-d. Fig. 9b shows an east-west section of the Wall-B, which is situated at the southern monastery area and oriented in north-south direction (Fig. 7). Upper part of the wall is eroded, and the top is rounded. Both the sides (east and west) are equally eroded. Maximum width is about 1.5 metres, and it's thinner than the original thickness of 2.4 metres. The basal part is more deeply eroded than the middle part of the wall. Other damaged walls show more or less similar features, indifferent to their positions and orientations. Common characteristics of the erosion are as follows:

Rapid erosion can be seen at the south-eastern end of the Wall-A (in circle of Fig. 7). The basal part was severely eroded in August, 2006 (broken lines in Fig. 10). The height of the wall was then about 4 m, but the basal part of 0.5 - 0.8 m from the ground surface was deeply undermined. The maximum depth of the erosion is about 0.6 m. It looks like a notch. About

prevent not only the failure or collapse of the walls, but also the decay by salt weathering. The conservation work will continue and drainage system be constructed until the end of 2008. It will be essential for the flow of surface rain. Topographic map (Figure 7) is applied to design and construction for their conservation works.

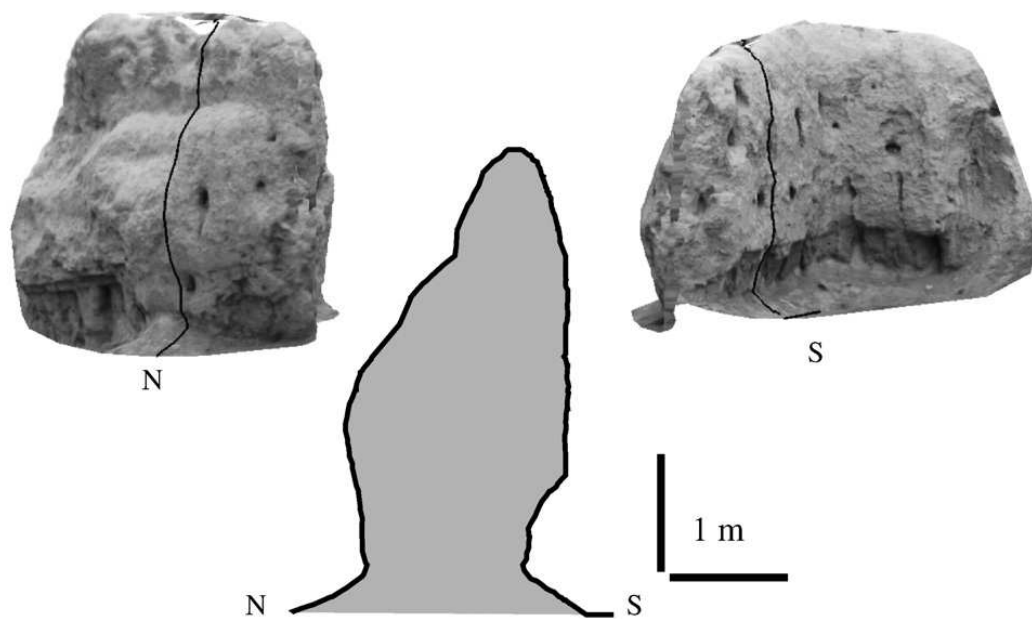
Fig. 8. A section of Wall A in north–south direction. Upper two photos show the positions of the section on texture mapping models.

was taken from the southwest direction (Fig. 2). The control points for each pair of stereo-photographs have 3-D coordinate, which were defined by the bench marks . Therefore we could establish the original mutual position of each DTM, and complete sections of each wall could be obtained. Fig. 8 shows a north-south section of the Wall-A (Fig. 7). The massive wall had been constructed with *pakhsa* blocks or mud bricks on *pakhsa* base, and the original shape of the section might be rectangular. The original thickness of the wall was 2.4 metres, which is recorded in Litvinskij and Zejmal' (2004). The original height of the wall is not clear for Wall-A, but the walls of the monastery area had average height of 2.5 metres with maximum of 5 metres (Litvinskij and Zejmal, 2004). Maximum width of the remained wall is about 2 metres (Fig. 9). In fact, the wall is largely eroded as seen in the sections. The current shape of the wall is much different from the original rectangular one due to erosion. First, upper part of the wall was strongly eroded and looks rounded. Both sides (north and south) are eroded deeply. The erosion of the north side is a little bit harder than the south side. Second, basal part was undermined to make shallow coves, and was eroded asymmetrically. Its south side was more deeply eroded than north side of the wall.

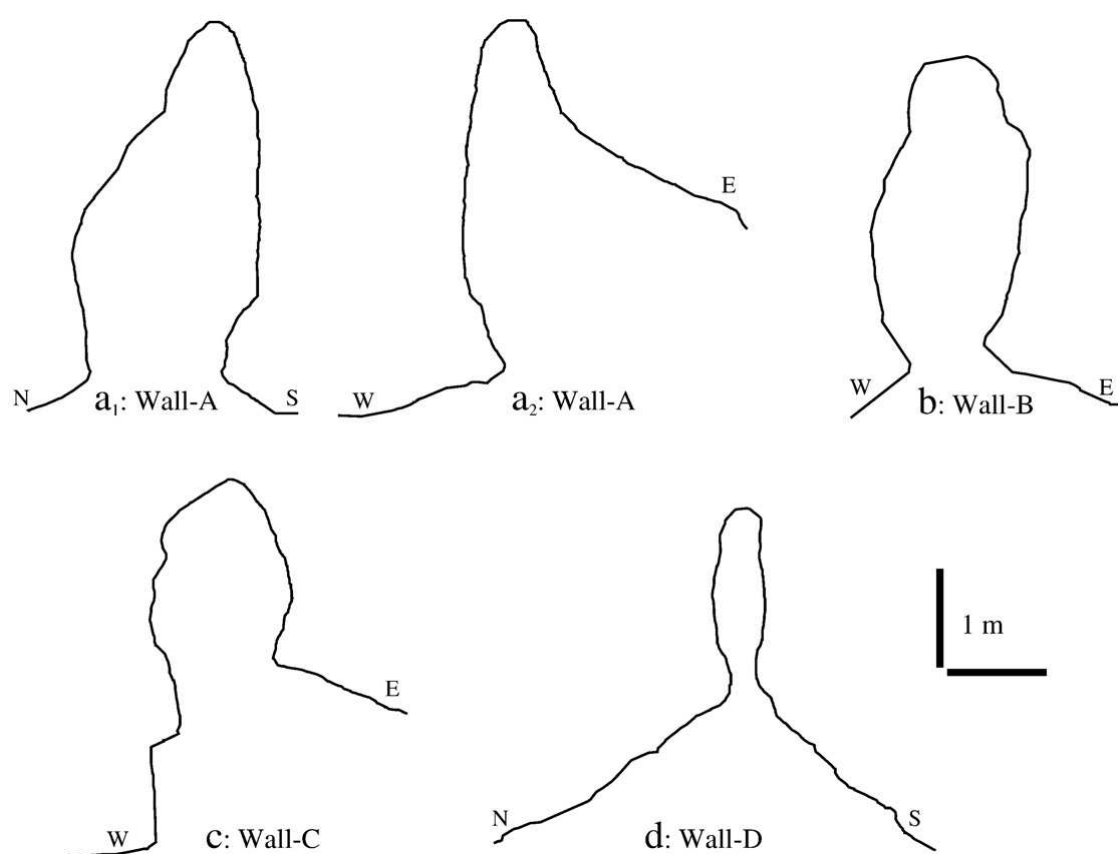
Fig. 9. Sections of the damaged walls. See Fig. 7 for locations of the walls.

1. The walls are largely eroded compare to the original outlines.
2. Top of the walls is eroded and rounded.
3. Basal part is more or less undermined and thinner than middle part of the walls.

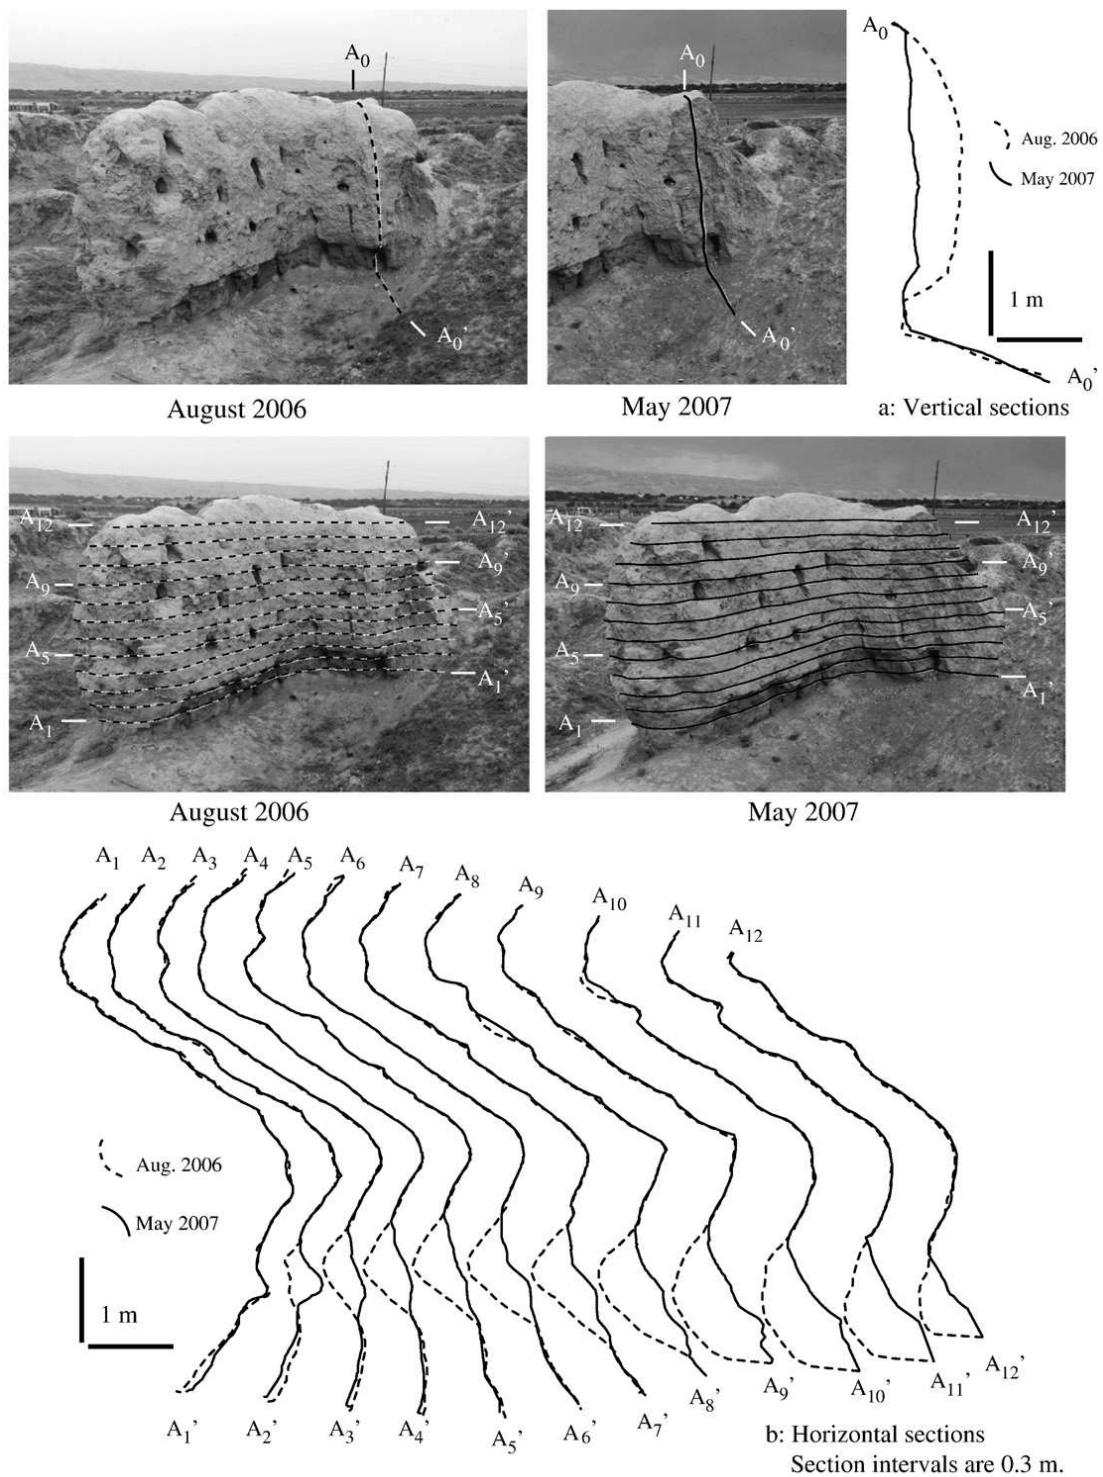
Fig. 10. Change of Wall A (L-shaped segment). Upper row: views from southwest, left in 2006, right in 2007. a: Vertical profiles. Middle row: photos showing reference horizontal sections, left in 2006, right in 2007. Lower row: ground plans of the reference horizontal sections. Southern rim collapsed between August 2006 and May 2007.

nine months after, top and middle part of the wall had been collapsed, and the surface of the wall became simple plane in May, 2007 (solid lines in Fig. 10). The volume of the collapsed part is about 1.6 m<sup>3</sup>, which is calculated from a series of eroded thickness measured at 0.1 m intervals of the height. Reference horizontal sections are shown in Fig. 11b, though the intervals of the height are 0.3 m. The sections of both 2006 and 2007 are made from DTMs which are calculated from the same 10 control points (Fig. 10a left). Therefore, both the sections are almost duplicated except for the collapsed or eroded parts (Fig. 10b). These data obtained by digital photogrammetry provide the quantitative basis to evaluate the advancing erosion process of the wall. We could successfully disclose the damage of the wall in the site of Ajina Tepa.

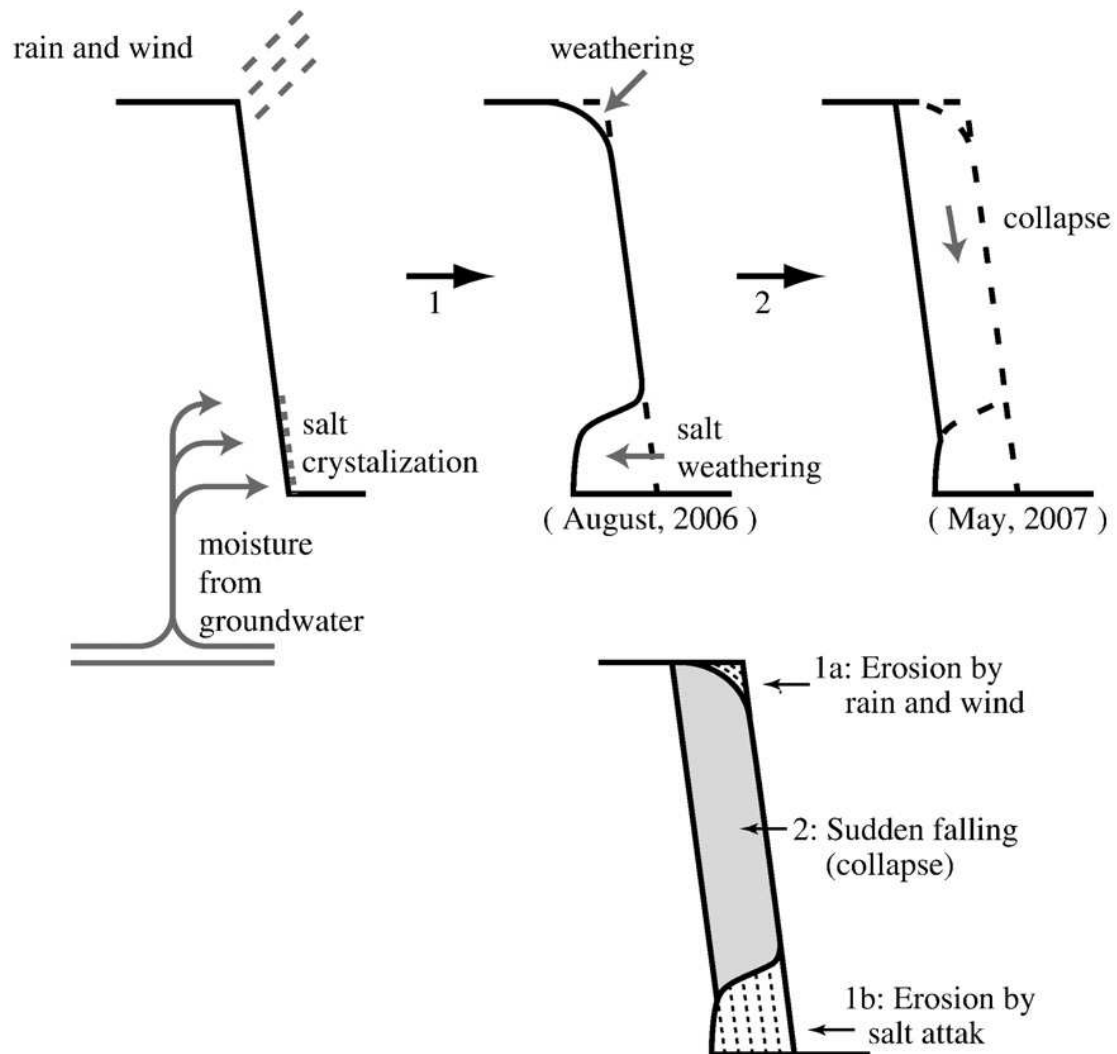
Fig. 11. Schematic erosional process of the wall. 1: Soluble salt is transported with capillary groundwater, and crystallized on the surface of the wall. Salt crystallization attacks and erodes the basal part of the wall. The top part of the wall is also eroded by rain and wind. 2: The upper wall, which lost support due to the thinning of the basal part, collapses suddenly. The wall surface becomes planar, and the erosion will continue to decay the wall.

Before the former excavations, the site was totally covered with sediments and formed as topographic mound (Litvinskij and Zejmal, 2004). After the excavations, appropriate preservation or protection work has not been done for the buildings in the site of Ajina Tepa. Therefore, the building walls have been exposed since 1975. The erosion test shows slow for mud brick and medium for *pakhsa* compare to the other earthen materials in central Asia. In contrast, the wetting and drying test shows very slight failure for both historical materials. Therefore, rain and wind might have been main erosive causes to the top of the walls for about 30 years. Winter is the rainy season in the area of Ajina Tepa, so the walls are progressively eroded by rain water in such season. The building wall was lost by the erosion, resulting to rounding of the top of the buildings (Fig. 11-1a).

halite, calcite and gypsum are the major salt minerals crystallized on the walls. Mud brick and *pakhsa* contain soluble salt, so these salts might be transformed by groundwater. Vertical profiles of evaporation rate were measured on the surface of the walls (Watanabe et al., 2008), demonstrating that the rate is maximum at the ground, and gradually decreases with the height. It indicates that the moisture is essentially supplied from the groundwater. On the height of 1 metre from the ground, the evaporation rate is small enough compared to the ground. The erosion of the basal part for each wall has less than 1 metre height. Therefore, it is clear that soluble salts were transported to the surface with capillary groundwater, and crystallized on the basal part of the walls accompanying by evaporation of groundwater as moisture. The current floor of the site is lower than the around topographic field and close to the groundwater table. Therefore it's easy for groundwater to evaporate on the floor in the site. The salts cause damage on the wall (Goudie and Viles, 1977), and combination of the wind and windblown silt strengthen the power of erosion. With the repetitions of the above process, the basal part became thinner and thinner than the middle part of the walls (Fig. 11-1b).

Due to the thinning of the basal part by salt attack, the upper wall lost support from the lower basal part. Eventually, protruded part of the wall was collapsed (Fig. 11-2). The collapse can be caused by structural weakness especially in rainy winter season, because earthen materials contain more moisture and have less strength. However earthquake or other exterior efficiency might affect the sudden failure of the wall. The thickness of the wall becomes thinner and the surface is planar after the collapse, but the erosion by soluble salt attack, rain, and wind continues to decay the wall (Fig. 11).

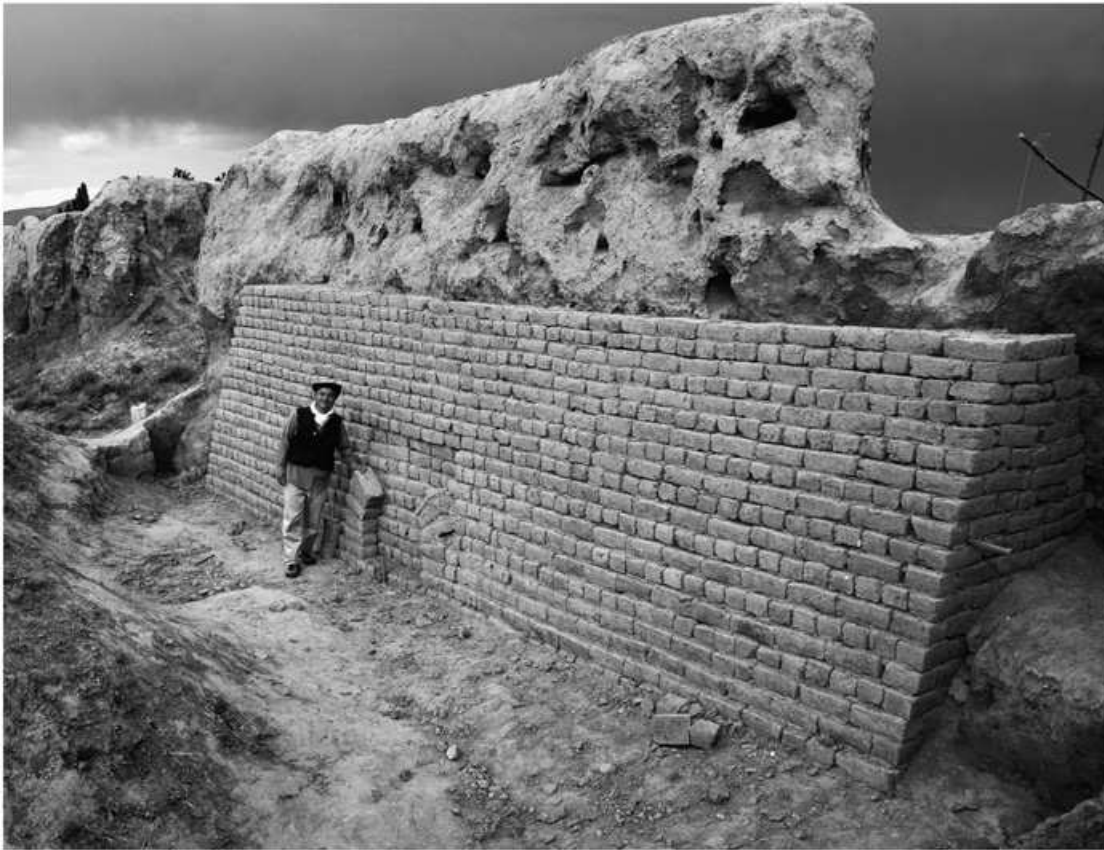
Fig. 13. An example of conservation work. Wall-B is supported by buttresses made of new mud bricks.

Conservation works have been done by this project (Fodde et al. 2008a, in print). Some unstable walls had been already supported by buttresses made of new mud brick and plaster (Fig. 13). The design of the wall is not vertical and the bottom is thicker than the top. This is to
